South Broad Street Bridge
Spanning the Elizabeth River
Elizabeth
Union County
New Jersey

HAER NO. NJ-39

RECORDING OF
SOUTH BROAD STREET BRIDGE
CITY OF ELIZABETH,
UNION COUNTY, NEW JERSEY

FOR
U.S.ARMY
CORPS OF ENGINEERS
NEW YORK DISTRICT
BY
HISTORIC SITES RESEARCH
PRINCETON, NEW JERSEY

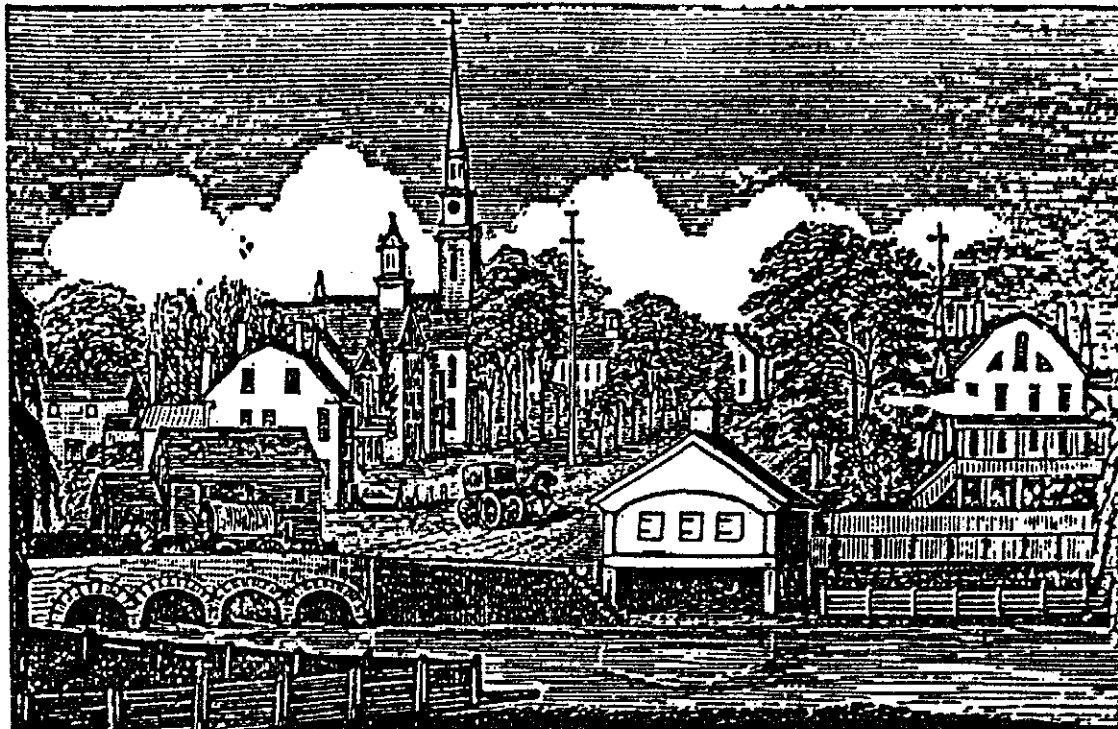
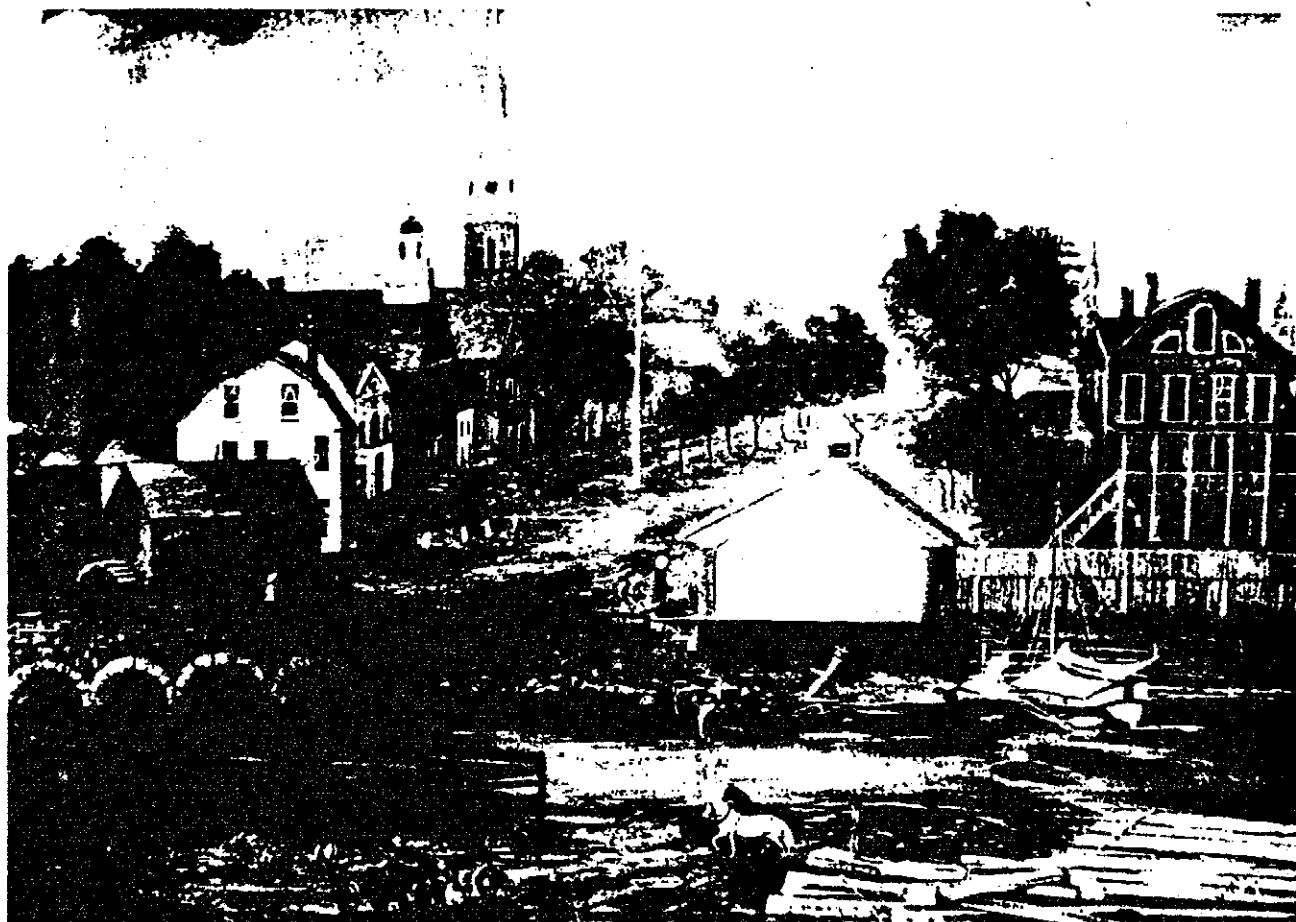
FIGURE 3

Looking up Broad Street from the Stone Bridge, 1795 and after.
(Thayer 1964: 153, original from Barber & Howe 1844: 159)

Painting in Elizabeth Free Library, signed "S.W.Alvars 97"
(probably derived from Barber & Howe engraving)

Research into primary records reveal that Thayer's illustration was taken from a woodcut engraving in the 1844 edition of Barber and Howe's Historical Collections of the State of New Jersey (1844:159, see Figure 3). Barber and Howe discuss this "annexed engraving" on the same page, stating that the Presbyterian Church which stands in the center of the woodcut was completed after 1792 on the site of an earlier Presbyterian Church that had been burned by the Hessians in 1780 during Baron Knyphausen's incursion (1844: 159-160). The woodcut also shows the Episcopal Church and the 2nd Presbyterian Church, the latter of which was constructed after 1819. Therefore this woodcut must have been made after 1819 and represents the bridge as it appeared around 1840. Another version of this scene is shown in an oil painting which hangs in the reference section of the Elizabeth Free Public Library (see Figure 3). This painting is signed by S.W. Alvars and has the figure '97' or possibly '77' which may represent a date (1897?). The painting is in undeteriorated condition and the style resembles latter 19th or early 20th century works. From this we conclude that the view drawn about 1840 shows a prior bridge, (the one verbally discussed by Magie) which crossed the river diagonally, and that the existing bridge, built in 1874, completely replaced the Colonial Period bridge.

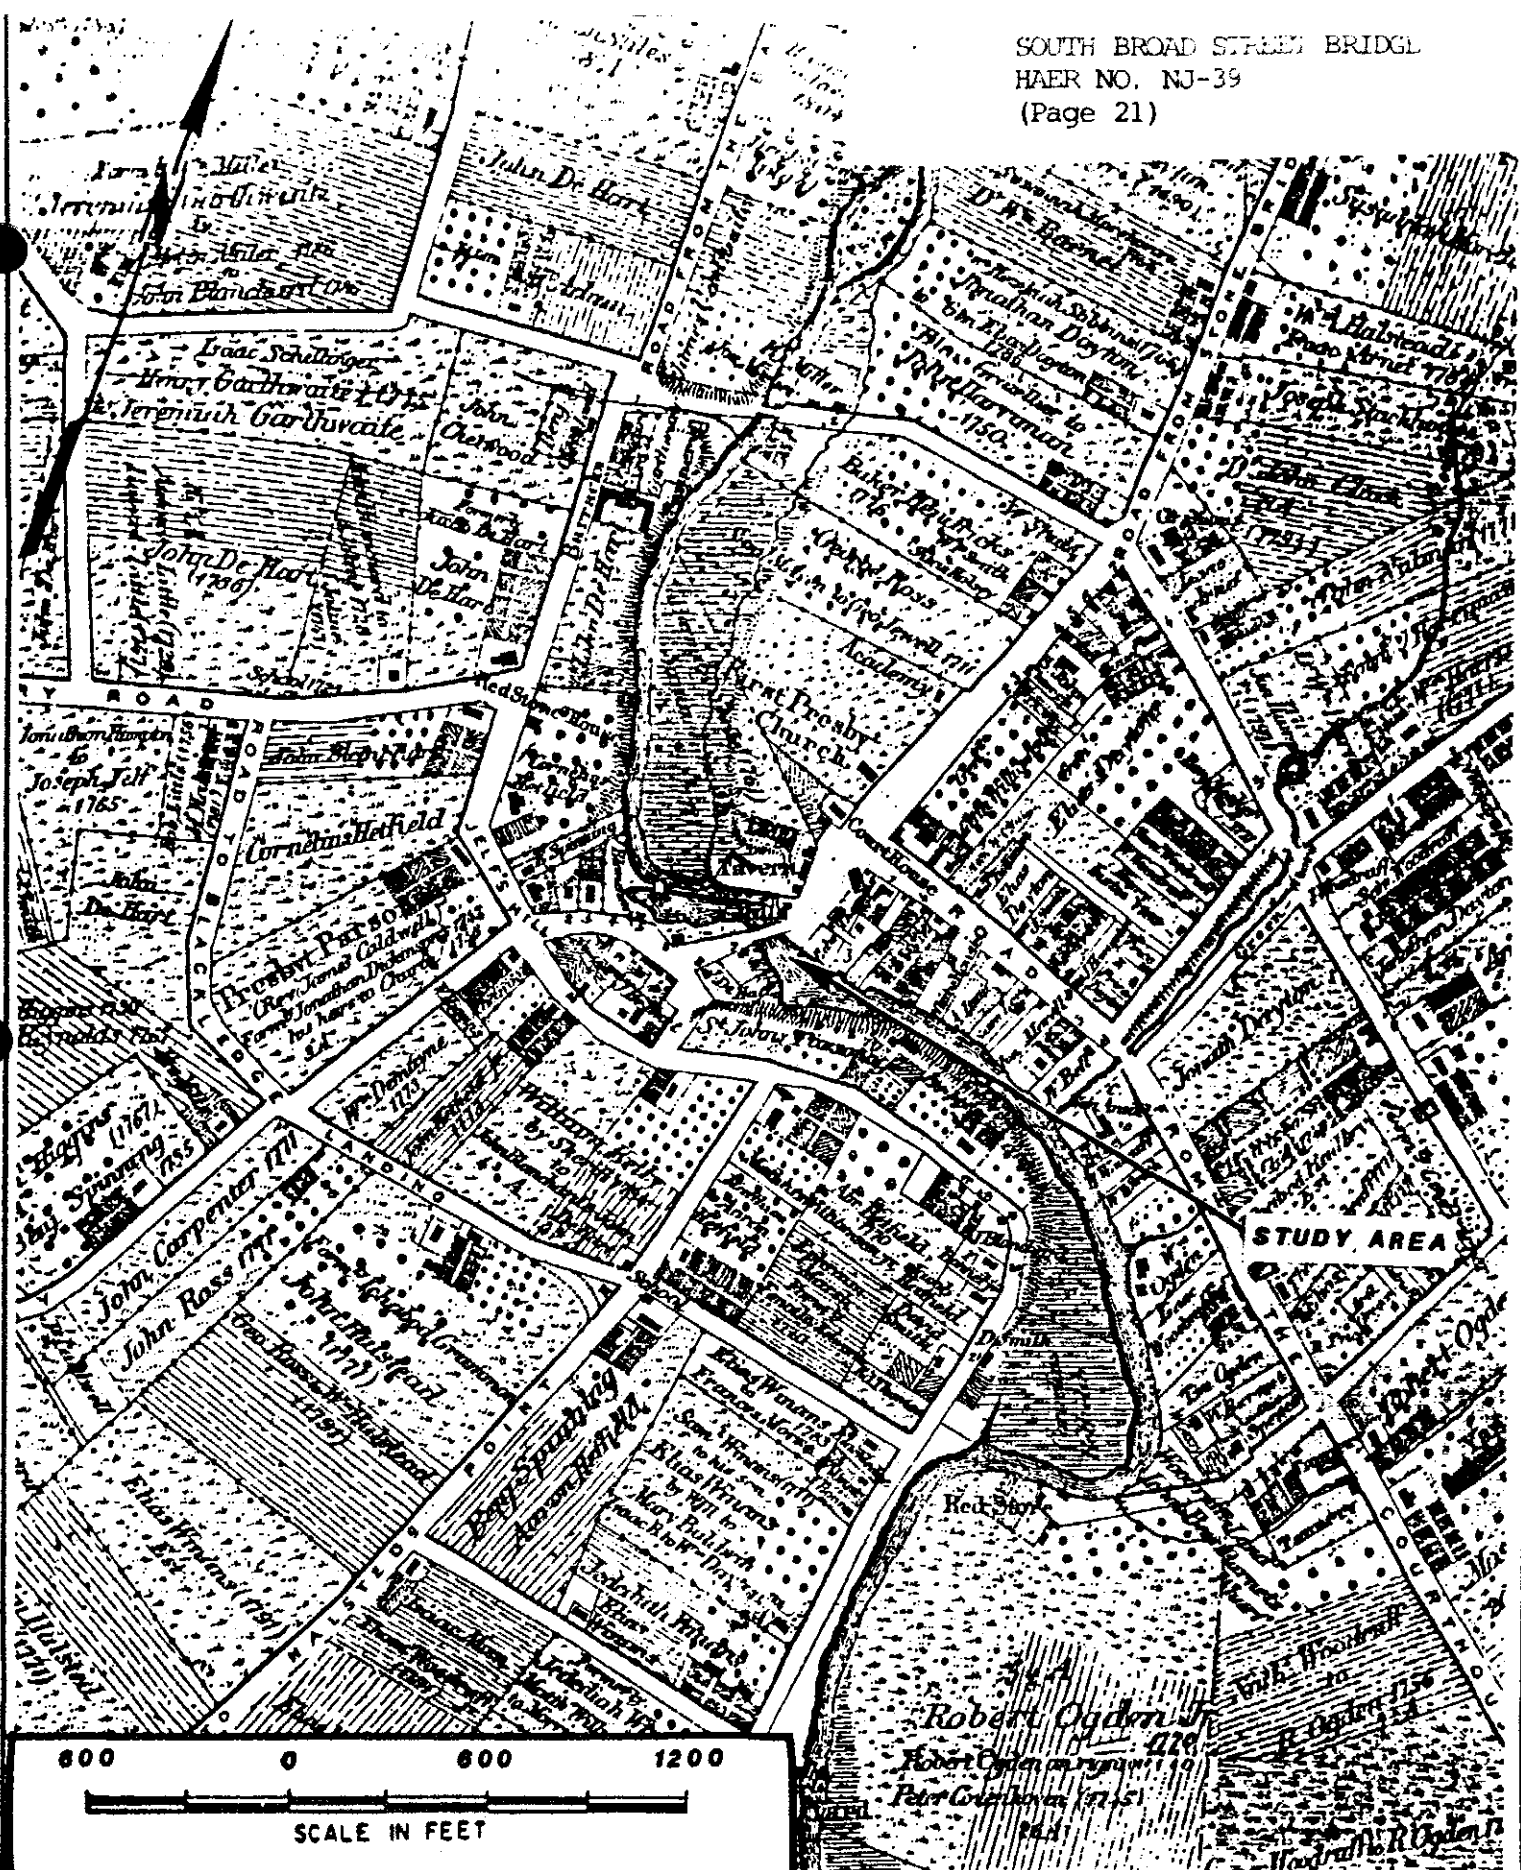
FIGURE 4

"MAP OF ELIZABETH TOWN," N.J."

----- Indicates present alignment of Elizabeth River

..... Indicates present alignment of roads and bridge

1783 was printed in 1879 (see Figure 4). It shows what is now Broad Street north of the Stone Bridge running almost due north on its present alignment, but with a narrow bridge turning south-where South Broad Street now runs. The 1879 version of this map has a contemporary map of the streets of Elizabeth printed on the reverse of the map, so that when held to the light, the viewer can see the superposition of changes made between the 1770's and the 1870's. Unfortunately, it is not possible to copy this superimposition, and the recent reissue of the map by the New Jersey Historical Society omits the 1879 rear overlay entirely. We have marked a copy of this map using the 1879 data and modern maps to show the difference between the late 18th century and modern alignment (Figure 5). This illustrates that the "Stone Bridge" of the Colonial period did not lie in the same position as the existing bridge, except possibly near the north end, and that its width was much narrower than the present bridge. The south end would have been where part of the A&P parking lot now stands.

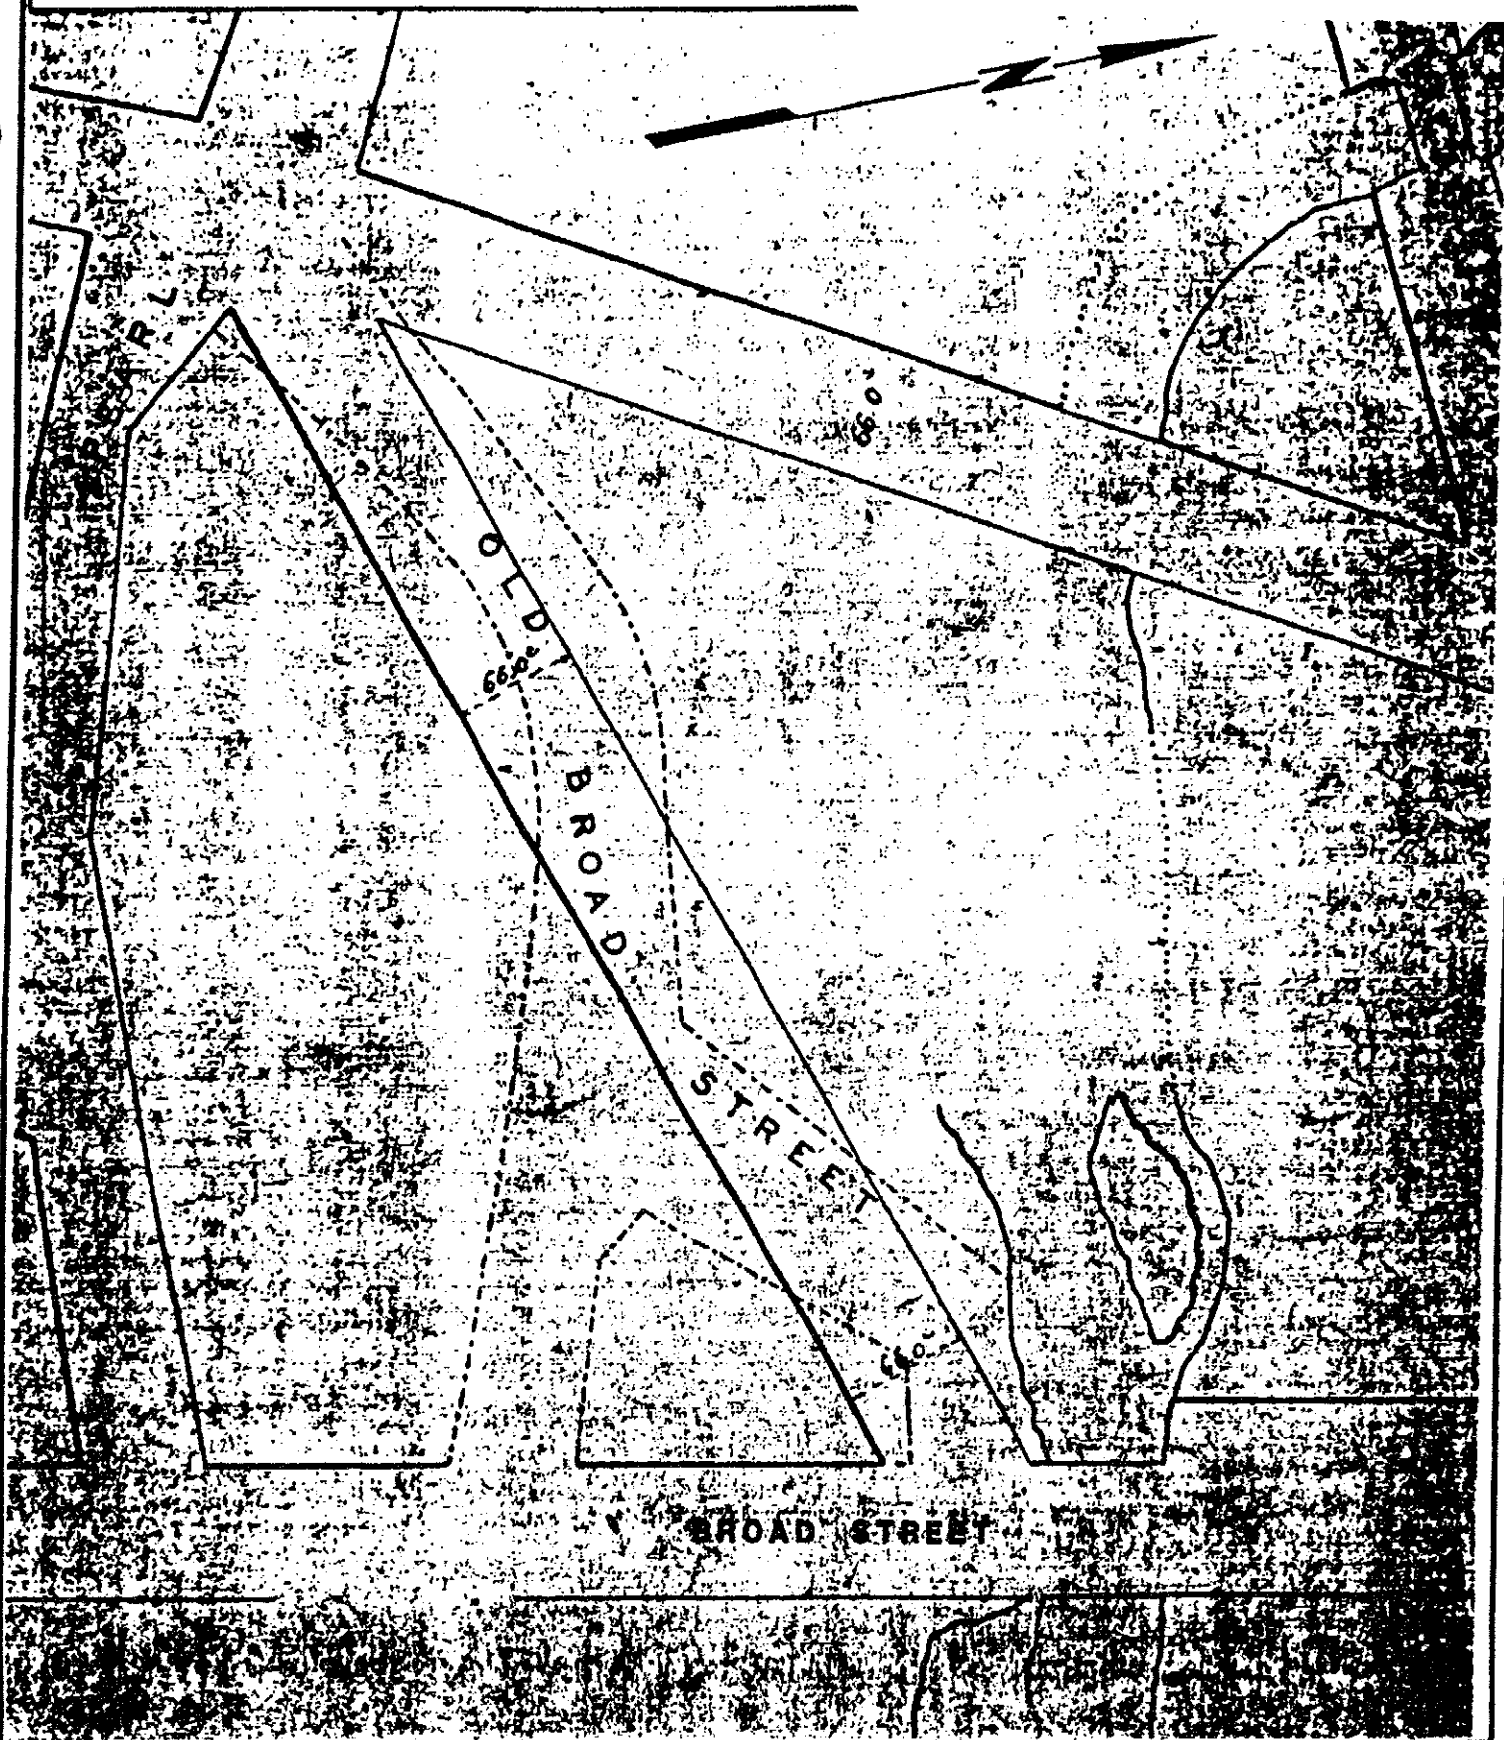
BROAD ST. BRIDGE DOCUMENTATION
ELIZABETH RIVER FLOOD CONTROL PROJECT
UNION COUNTY, N.J. FIGURE 7

"COMMISSIONER'S MAP OF ELIZABETH"

Yet another right-of-way map, made in 1869, shows "Old Broad Street", which preserved the location of the former south terminus for the 18th century bridge, in the process of being vacated and replaced by a new straight road which became Washington Avenue. (This avenue has since also been vacated and lies under the A & P building and parking lot.) The bridge shown in 1868 is much wider than that of 1775-1783 or even 1850-1858, extending to the east margin of the Broad Street right-of-way, but not the west margin. A small channel shown just upstream of the bridge is probably the remains of the mill race (Figure 7). A general map of Elizabeth was published in Beers State Atlas a few years later, and reflects the new arrangement, except that it still shows "Old Broad Street ", indicating that Washington Avenue had not yet become official, or that the atlas was slightly behind in presenting data here (Figure 8).

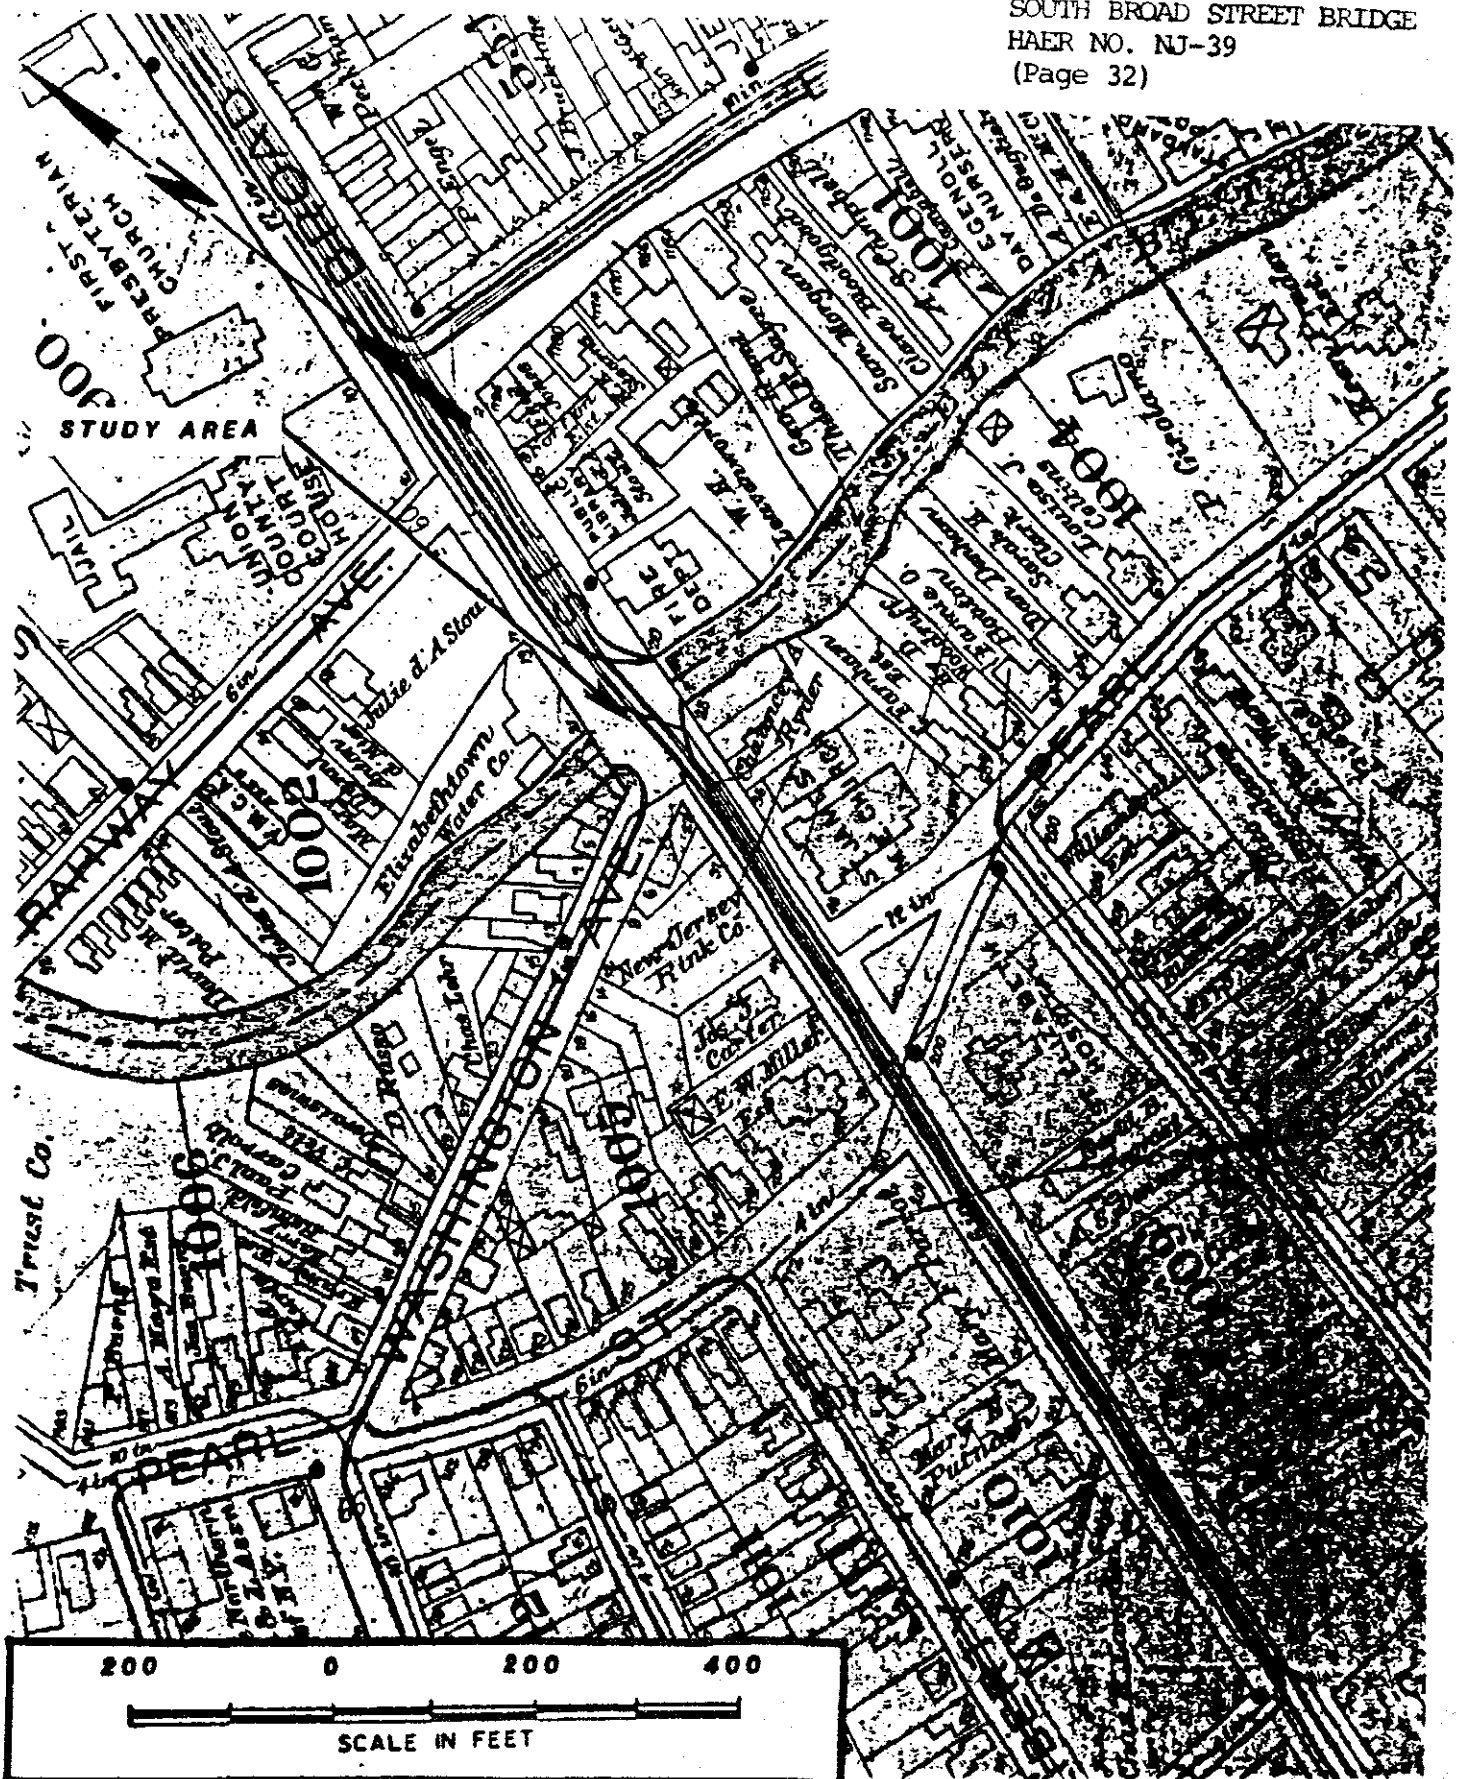
BROAD ST. BRIDGE DOCUMENTATION
ELIZABETH RIVER FLOOD CONTROL PROJECT
UNION COUNTY, N.J.
FIGURE 11

"ATLAS OF UNION COUNTY"

ROBINSON 1906

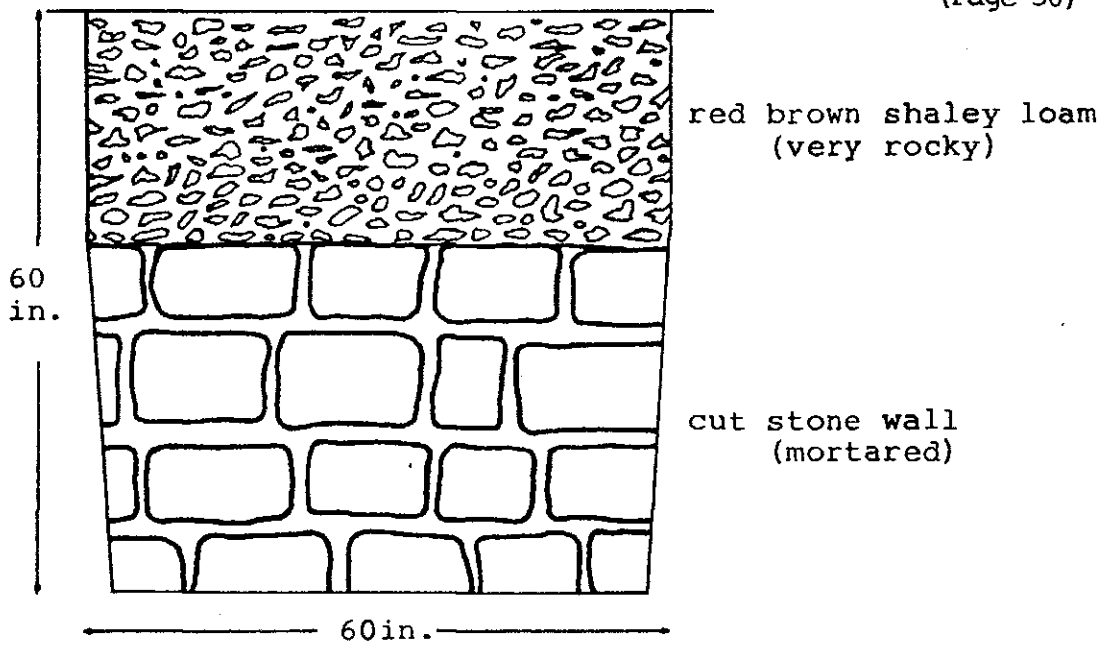
TEST 1 (facing west)

TEST PIT PROFILES

Test 1 was a 60" by 42" rectangle excavated to a depth of 60" below ground surface. The southwest corner of the test was 80" north of the end of the concrete bridge rail (at the projected location of a fourth arch, if the present bridge contained one). The west wall of the test was excavated against the northward extended portion of the bridge's east wall, directly parallel to the buried abutment wall, southwest of the front corner of the fire house and along the edge of the sidewalk. This buried wall is shown as one of "Present Walls to be removed to 18 inches Below Surface Grade" on the 1927 drawing. Soils were excavated from the test through 1/2 hardware cloth screens, and carefully sifted and inspected for archaeological remains. The soil was a red brown shaly loam with many rocks and some cultural debris consisting of furnace ash and clinker, broken ironstone, late 19th century bottle glass and window glass and two saggars from a ceramic kiln. None of the material was earlier than circa 1880 and could have been as late as 1920. All material was randomly scattered in the soil which had been deposited here as landfill.
